LOCHMERE DAM

NH 00015

PHASE I INSPECTION REPORT  
NATIONAL DAM INSPECTION PROGRAM

NOVEMBER 1978

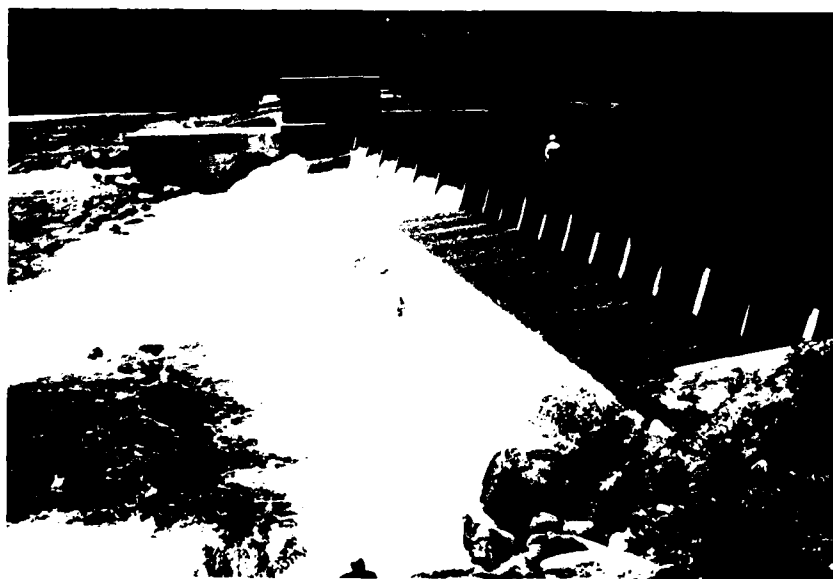
Overview from left abutment
